# **STRUCTURAL INTEGRITY RESERVE STUDY**

## **FOR SANDY KEY CONDOMINIUMS**

### **PENSACOLA, FLORIDA**

**Report Date: 1-2-2024**

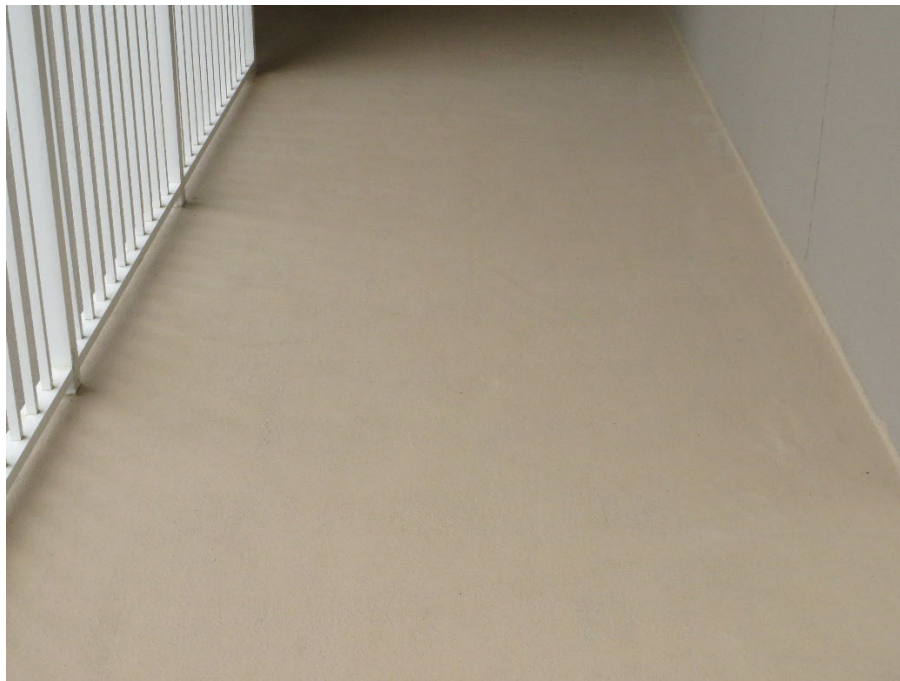
**Primary Structural System**

At some point in the foreseeable future, the association should expect to incur costs for a major restoration of concrete balconies. This would include concrete balcony concrete repairs, balcony re-surfacing and waterproofing. We have seen costs ranging between \$6-7 per sq.ft. in most cases. Costs include small concrete spall repair, cleaning surface and placing a topcoat of waterproofing.

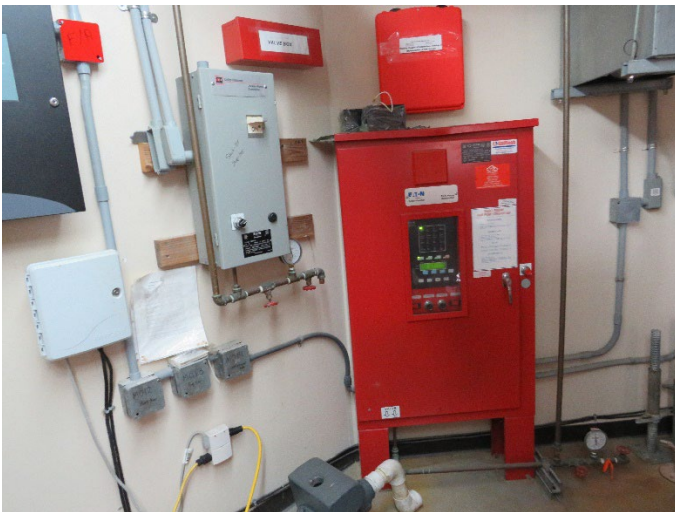
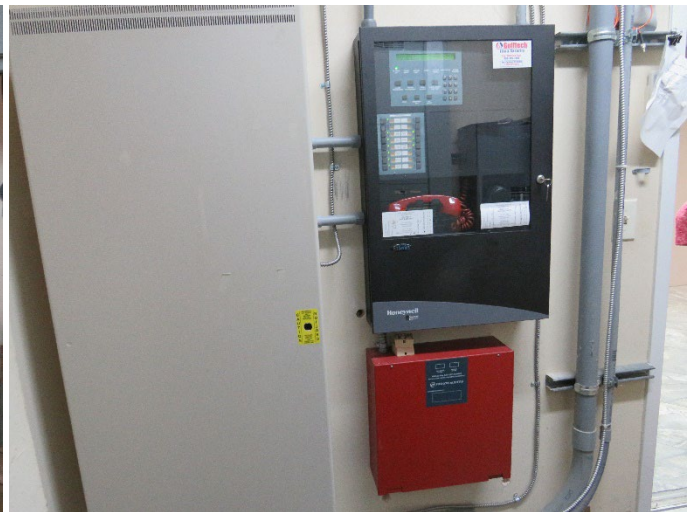
#### Fire Alarm System Modernization

The existing fire alarm system is being maintained and serviced yearly by Gulftech Fire & Security of Pensacola, Florida. The existing control panel is a Honeywell E3 Series.

Due to improvements in technology and/or parts obsolescence, major modernization of fire alarm system components (panels, pull stations, horns/strobes, detectors, hoses) is typically necessary on a 20-30 year schedule. Parts for the existing system is still available, so a replacement lower 20-year expected life span has been chosen for expense consideration.

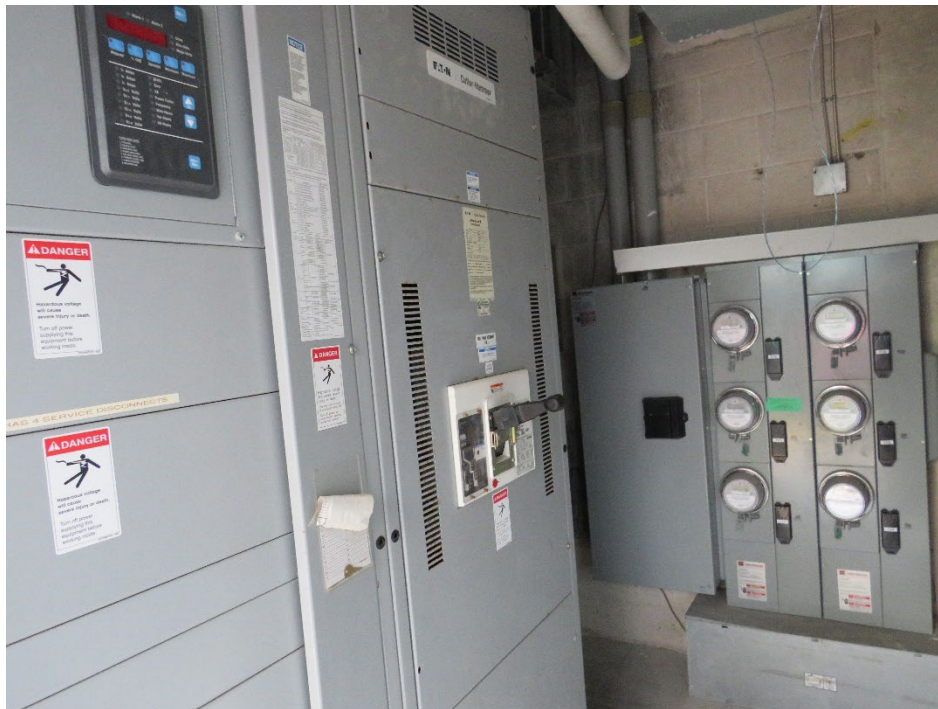
#### Electrical

The electrical switchboard is a Cutler-Hammer installed in October 2005.

Due to the remaining life being greater than 25 years and a continuous maintenance program, no reserve money is required to be set aside.

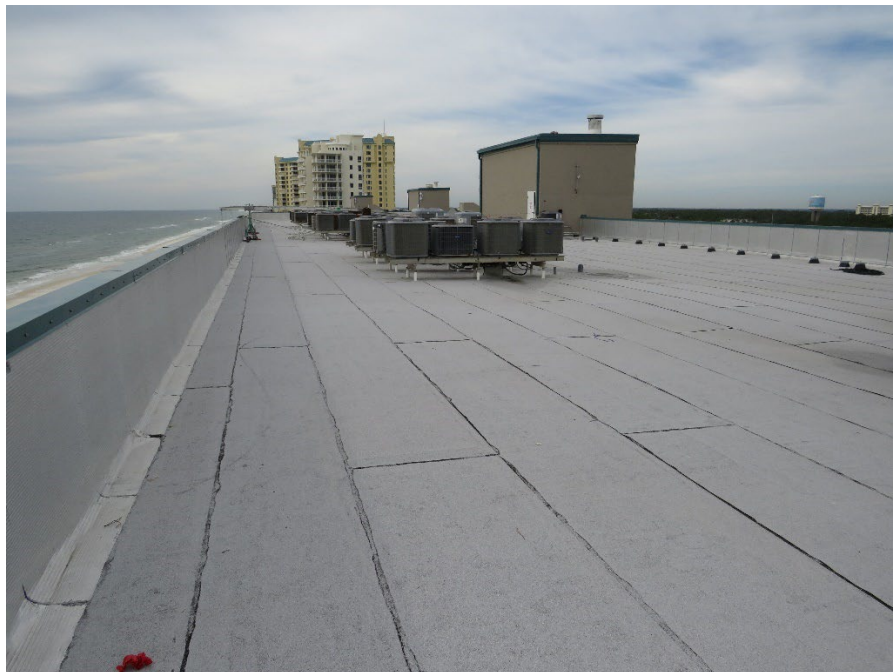
#### Flat Roofing

The elevator roofs were coated with liquid silicone in 2023. The current cost estimate includes applying a surface coating or new membrane to gain additional roof life without performing a complete roof tear off down to the substrate.

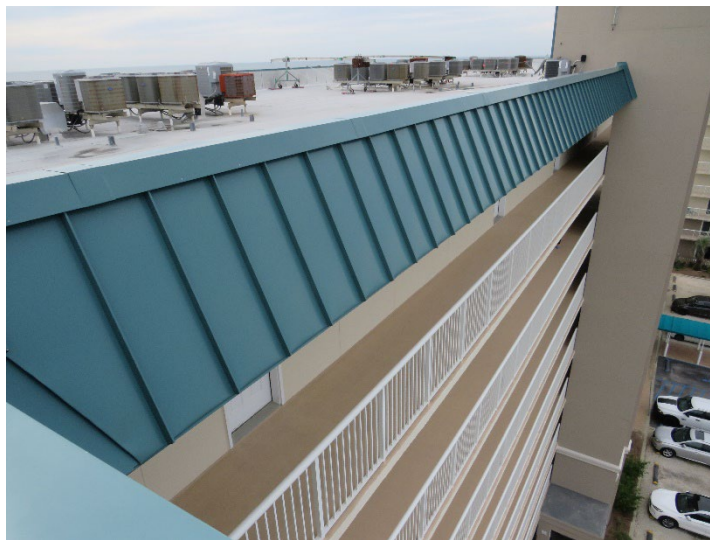
**Roofing, Metal**

Metal roofs have a minimum expected life cycle of 25 years, which assumes proper design, installation, and routine maintenance. The current cost reflects recent replacement cost includes removal and disposal of the existing roofing, typical minor repairs to the underlying roof structures, flashing, as needed repair/replacement of fascia, soffits, and installation of like roofing.

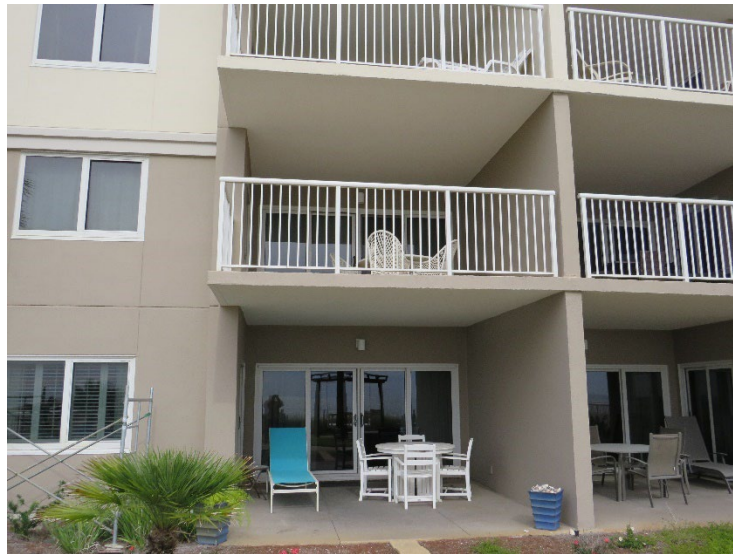
#### Windows/Doors

Common area exterior windows and doors are components that in conjunction with the other items in the structural integrity reserve study encapsulate the building envelope resulting in a complete waterproof structure. Exterior windows and doors of concern are those on the lower 30 feet of the building that gets the blunt of any rain or storm event. When maintained by recoating frames, replacing sealants and glazing, these windows and doors can last past their life expectancy. Sealants, glazing and compromised glass was replaced in 2023. Expectant life is 25 years; therefore, no reserve funds are required.
